Get smart about Lionel's postwar F3s

How Lionel painted three classics

by Len Carparelli | photography by William Zuback

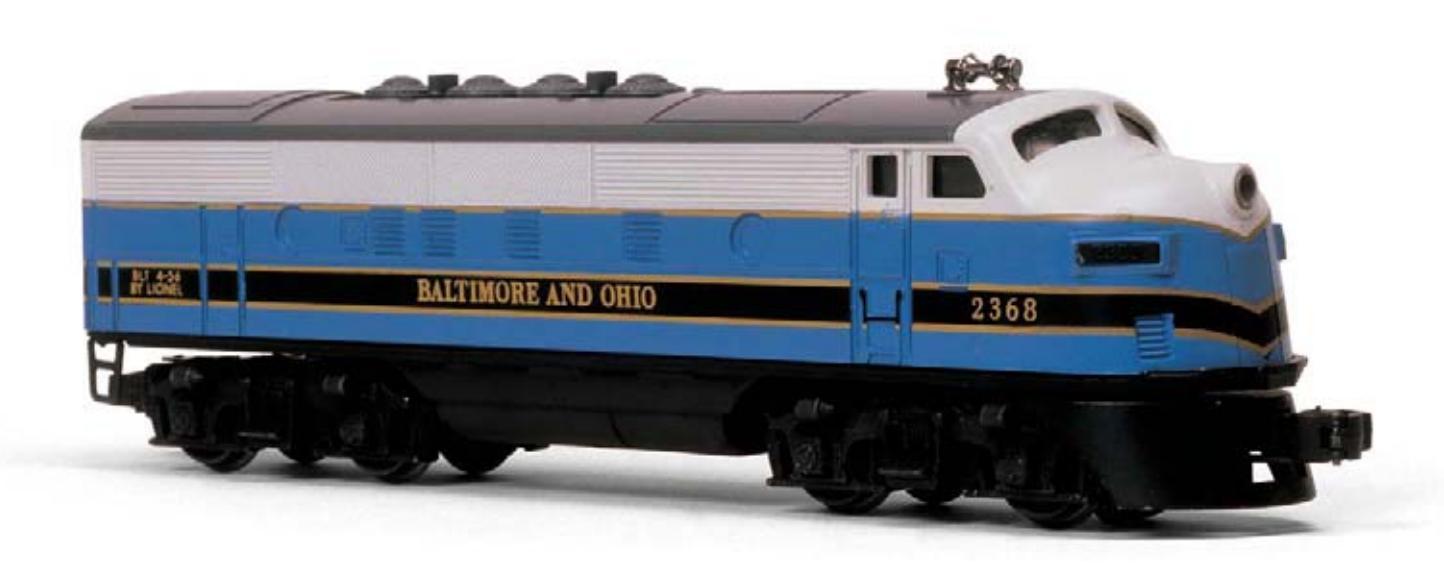
▼ Note the improper registration lineup in the yellow and black striping of this no. 2368 Baltimore & Ohio A unit. The sides were striped first using the wet-on-wet process that Lionel also used on Santa Fe F3s.

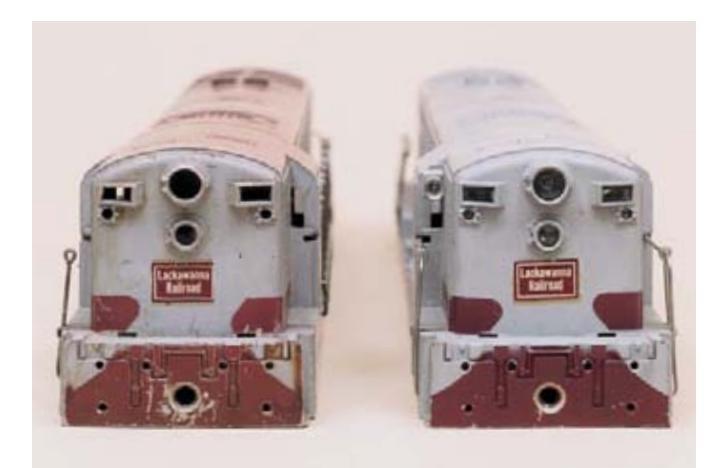
An example of a paint mask gone awry. Note the right-hand maroon stripe on the Train Master to the left. The stripe was painted upside down.

An interesting error is seen in photo on page 61. The sideby-side Train Masters appear the same, but look closer. The production worker used the wrong tape mask and the maroon band design on the right-hand side of the unit on

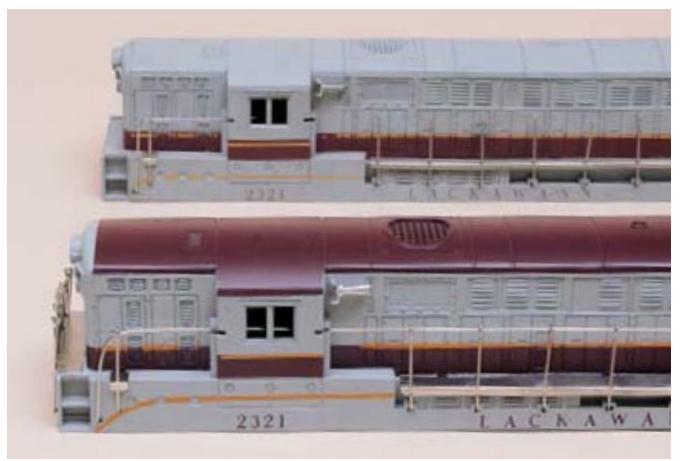
Most original Lackawannas have yellow stripes that are too low. Repaints usually have more precise striping.

Another clue is the yellow stripe alongside the cab.

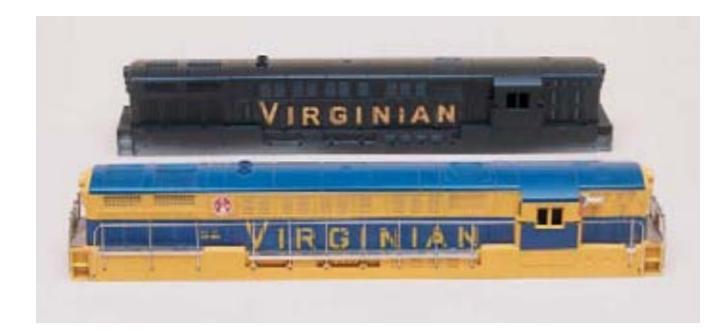
Repainted Train Masters often have the letters VIRGINIAN applied slightly higher than the postwar version. This is due to a limitation in the screen printing process that requires space to accommodate the frame's edge.

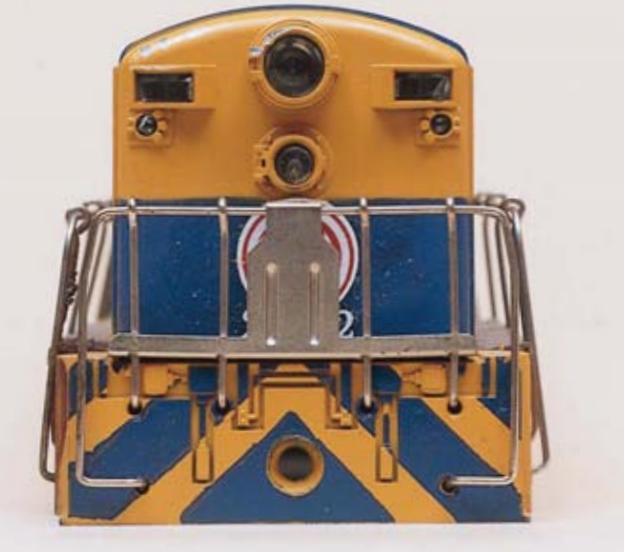
Original warning stripes were often blurred or grainy when compared to the clean, precise edges of a repainted Virginian's warning stripes.

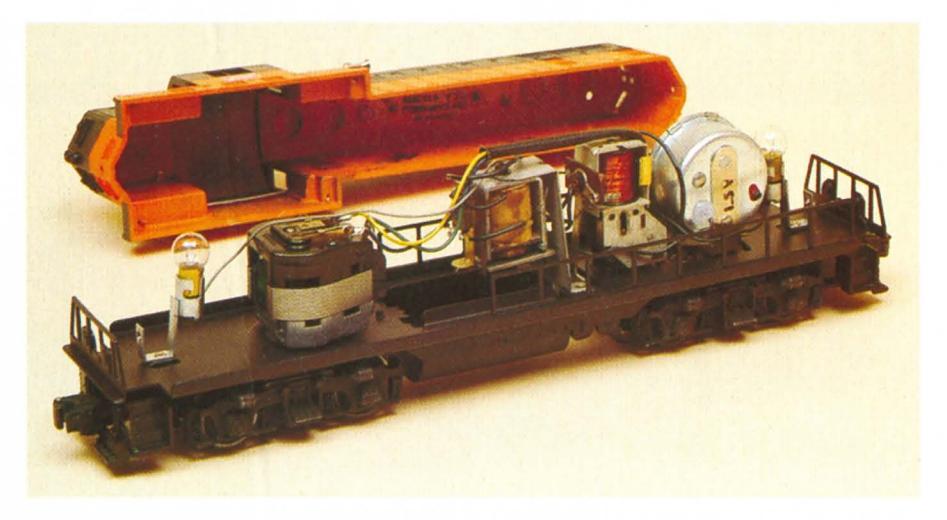
Sharp-eyed readers may be able to date this motor assembly (right) to 1965 or 1966 by the fact that the armature windings are green, while the field windings are red. All 1955 vintage motors should have orange wire on both the field and armature assemblies.

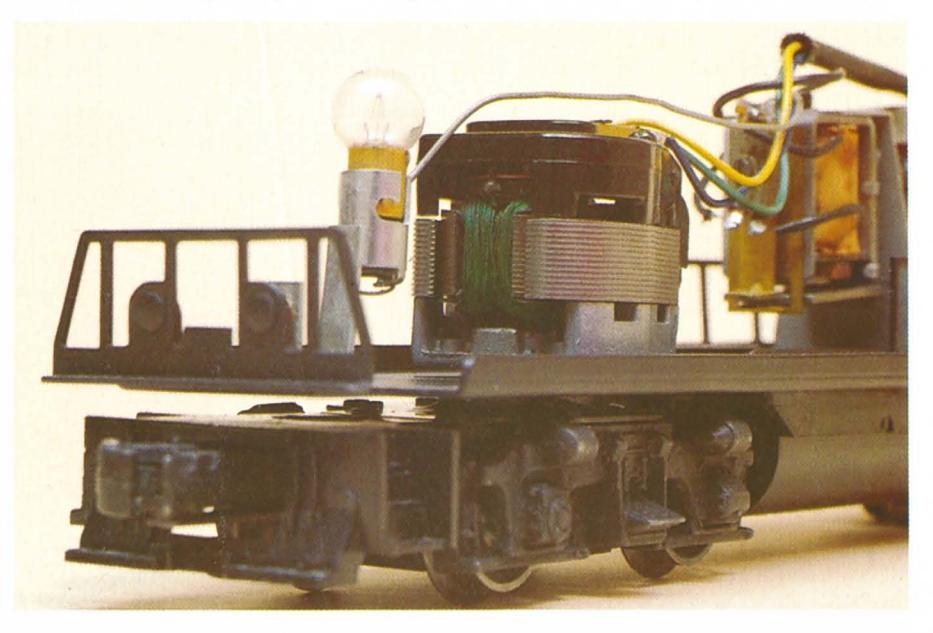
The inside of the restored no. 2338 Geep shell has not been painted black, as most originals are. On the chassis, note the operating horn assembly (part no. 2367-55) has been replaced with a new part.

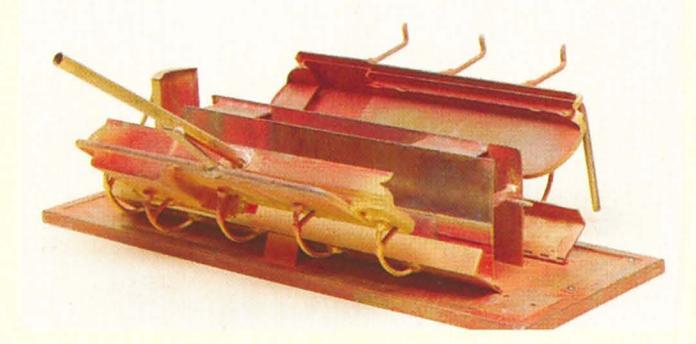
The brass and copper metal paint mask, above, was made for decorating the no. 2349 GP9. This mask, and others like it, were used to paint every multi-colored item made by Lionel from 1955 onward. The opened mask looks like a book, with two hinged sides resting on pre-set stops. Below, a Geep shell, previously painted black, is inserted into the holding fixture of the mask. The mask is closed and locked into place.

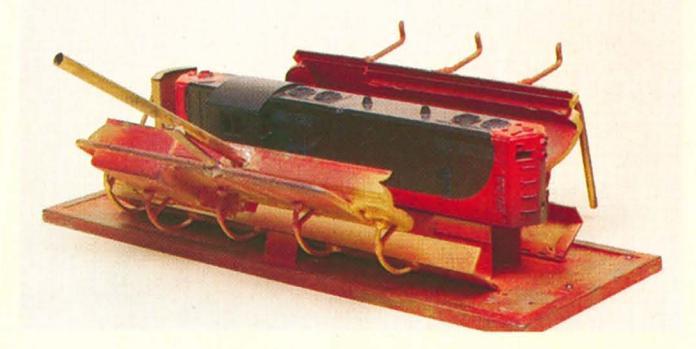
The mask has an engraved plate bearing the number 2349-M-3A2R2.

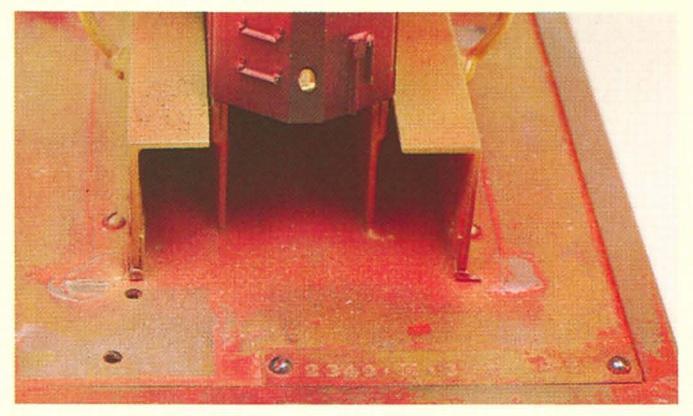
The Geep shell above is painted red, with the pre-formed and -shaped mask automatically creating the correct design. Using an ejector lever, the shell is loosened from the holding fixture, allowing the operator to remove the freshly painted shell. It would be placed on the drying rack. Once dry, it would be placed in the next mask where the gold areas are painted. Below, the paint mask bears the engraved serial number: 2349-M-3A2R2.

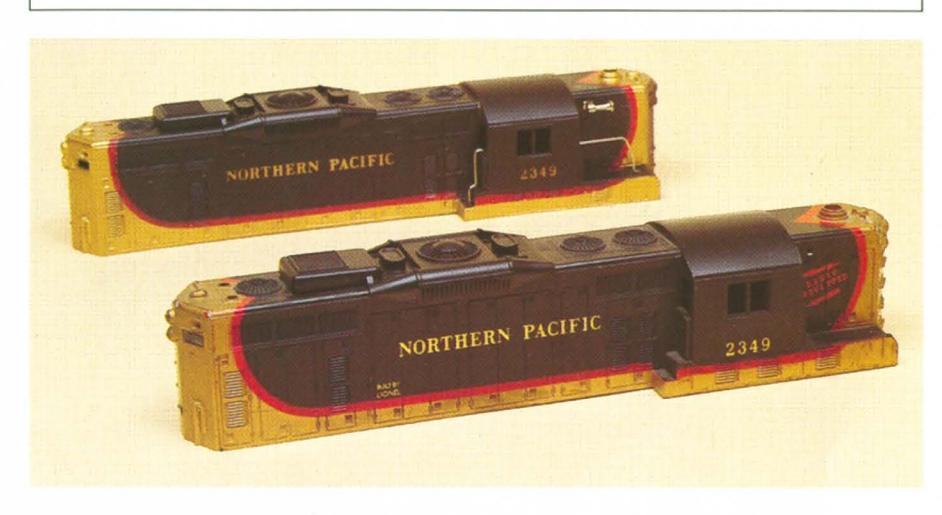
Original (front) and restored (rear) no. 2349 Northern Pacific Geeps. The original lettering is bright. shiny, and very metallic-looking, since it was heat-stamped using gold-leaf ribbon. Using the screenprinting method, the ink used can only approximate, not duplicate, that metallic look.

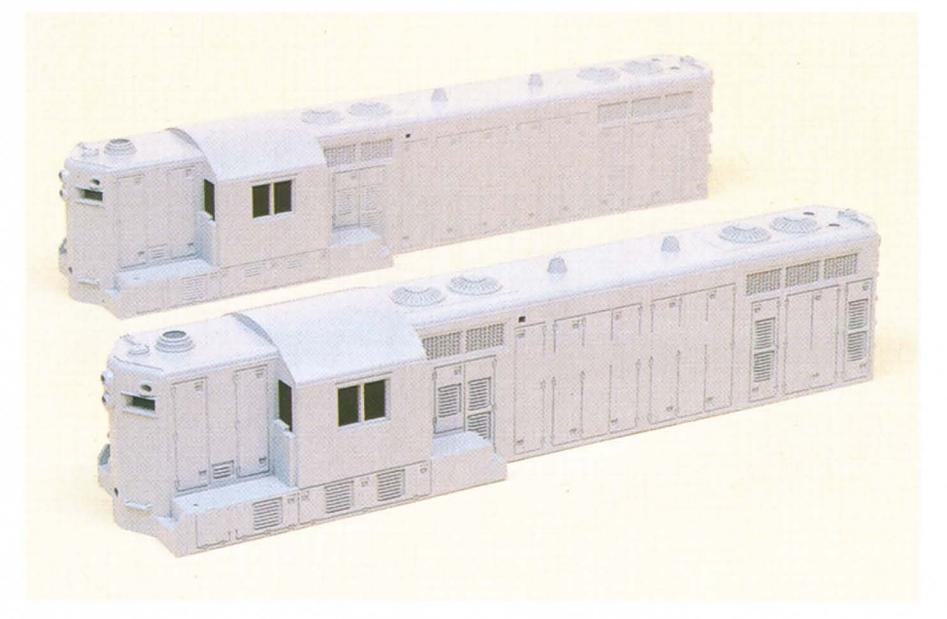
These two shells illustrate some of the changes made to the mold by MPC. Approximately 5/8" below the cab window you can see two sets of louvers. On the postwar model, the front louvers extend all the way down to the bottom parting line. The MPC version has effectively cut these louvers in half. Also note along the engine hood section, the simulated access door lines have been drastically cut on the MPC version, while the postwar version has only a small section interrupted.

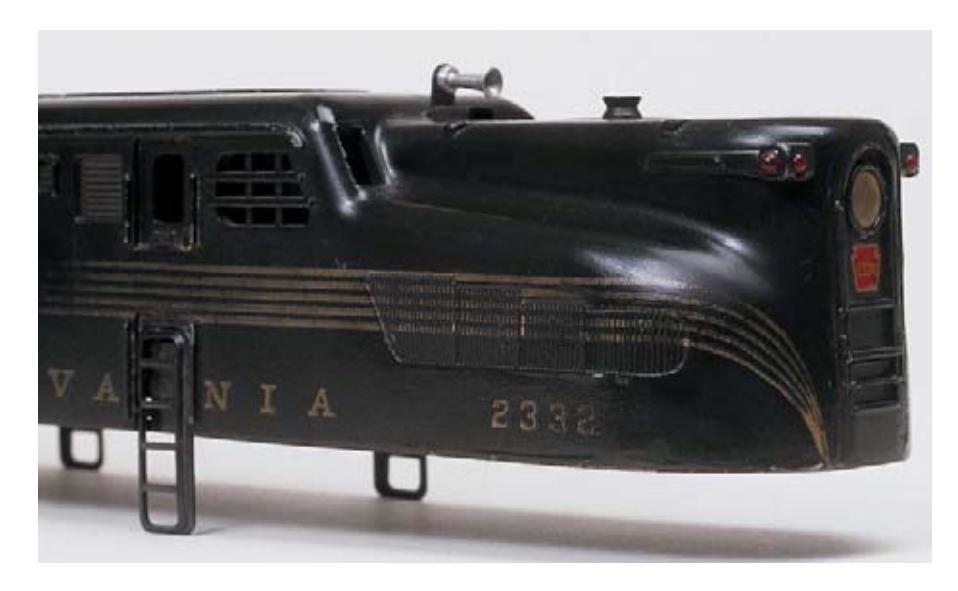
The striping was set too high on this original no. 2332. As you can see, the roller pad used to spread ink on the shell couldn't accommodate the sharp curve of the body.

Lionel corrected this problem by situating the bodies in the "nests" differently until the striping was printed a bit lower. This change to a lower lineup was evident on twin-motor GG1s, which exhibit a break by the cab ladders and have stripe points cut off at each end.

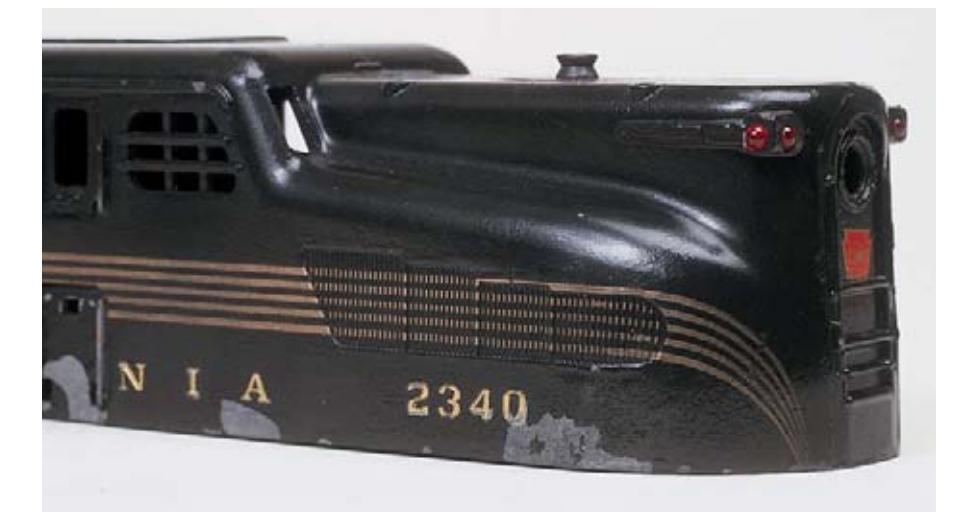
The most unusual GG1 may be the no. 2340. Its lettering has two distinct typefaces, serif on one side (shown here) and sans serif on the other.

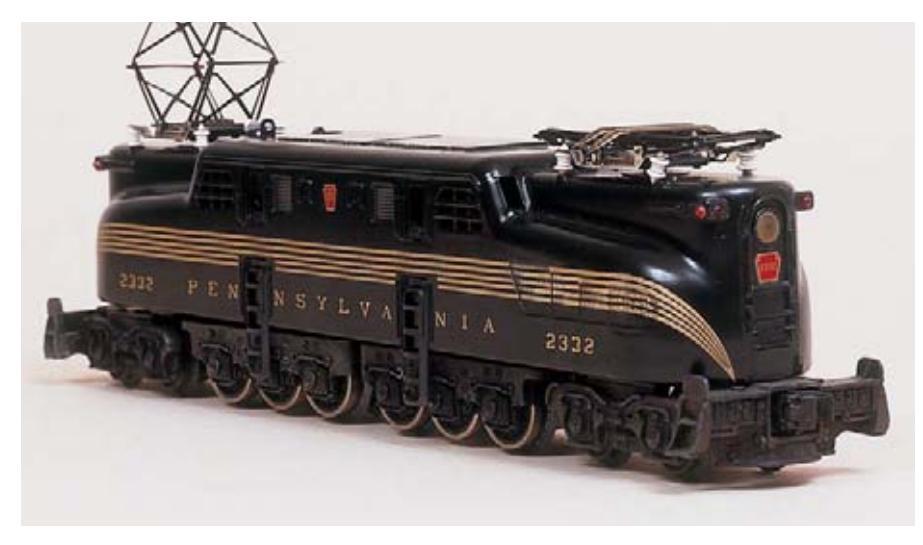
Because the stripes on so many original GG1s fade badly, more collectors and operators elect to buy handsome restorations, such as this one, done by the author at L & L Screen Printing Co.

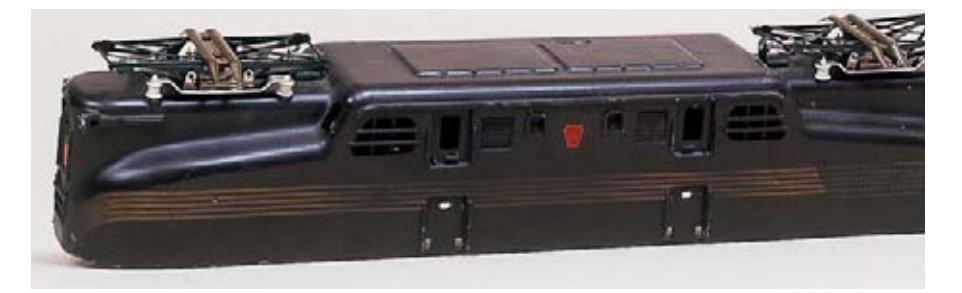
Lionel inadvertently omitted the lettering from one side of this no. 2360 locomotive. This collectible piece indicates that the company striped its GG1s first and then stamped on the lettering and numbers. This sequence makes sense because, if an error were made with the striping, it could easily be washed off and done again. By contrast, replacing the striping would have been more difficult if the heat-stamped lettering was already in place.

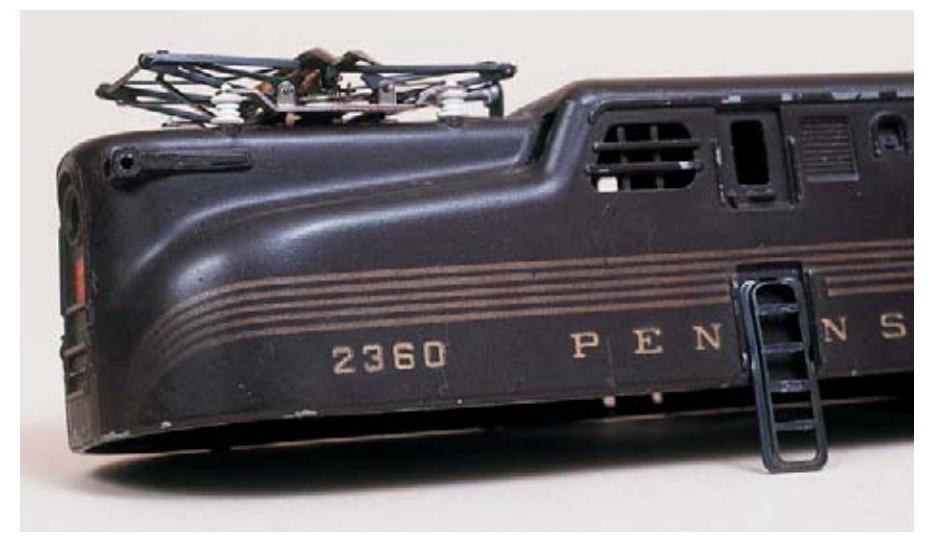
The striping was set too low on this original 2360. The ladder detail effectively cuts off the lower striping on the sides, and the points of the stripes are left off at the end.

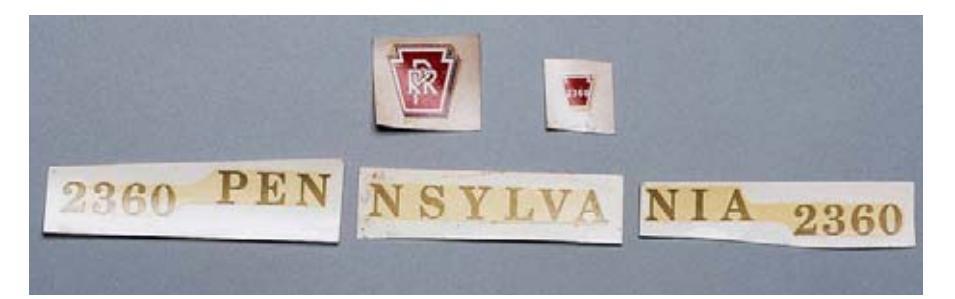
Lionel used decals to letter the 1963 version of the no. 2360 GG1. This original set of decals was manufactured by Meyercord Co. of Chicago.

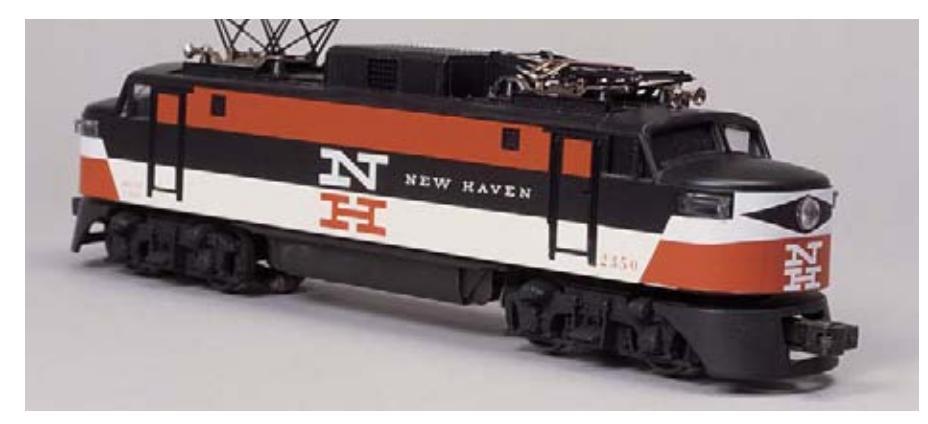
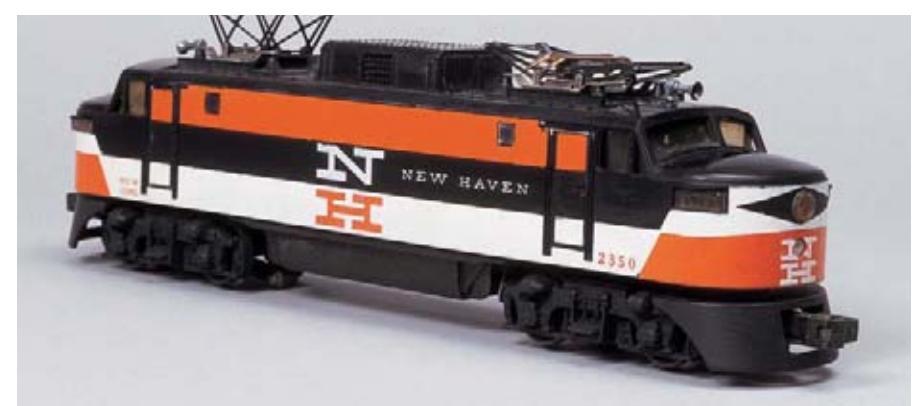
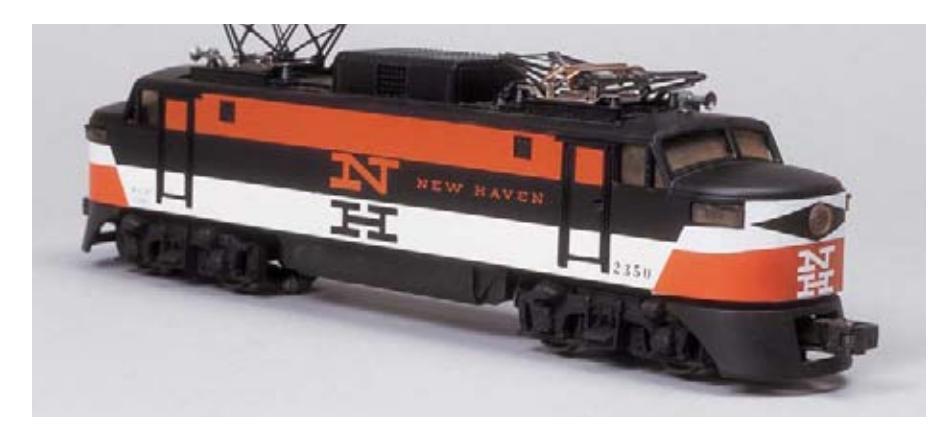
TOP AND CENTER LEFT: The "regular" no. 2350 New Havens set the standard that other 2350s ignore: the proper white "N" and orange "H" heatstamped lettering, silk-screen printing that necessitated the breaks in the orange and white stripes around the doors, and a nose decal or a painted nose. Both examples here are reproductions, one with a flexible white-vinyl decal (that replaces the original yellowed cellophane decal Lionel designed) and the other with a painted-on nose emblem and an exposed rivet. BOTTOM LEFT: Falling under the heading "what were they thinking," this orange "N" black "H" New Haven EP-5 remains one of the more interesting factory errors in postwar Lionel's history.

Lionel created the breaks in these color bands to accommodate the silk screening used to process the colors. Silk-screen printing does not work well in holes, depressions, or surface irregularities, where the printing tends to blur, so artwork has to be designed to compensate. Although the white and orange stripes were silk-screened onto original "regular" New Havens, the locomotive lettering and numbers were

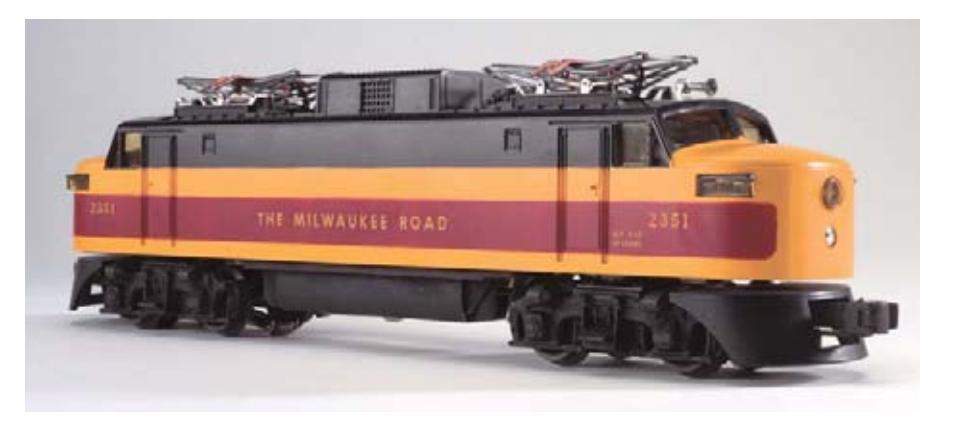
The no. 2351 Milwaukee Road EP-5 had only a quasi-variation. Some examples simply relied on the coloring provided by the yellow plastic shell instead of a light coat of yellow paint.

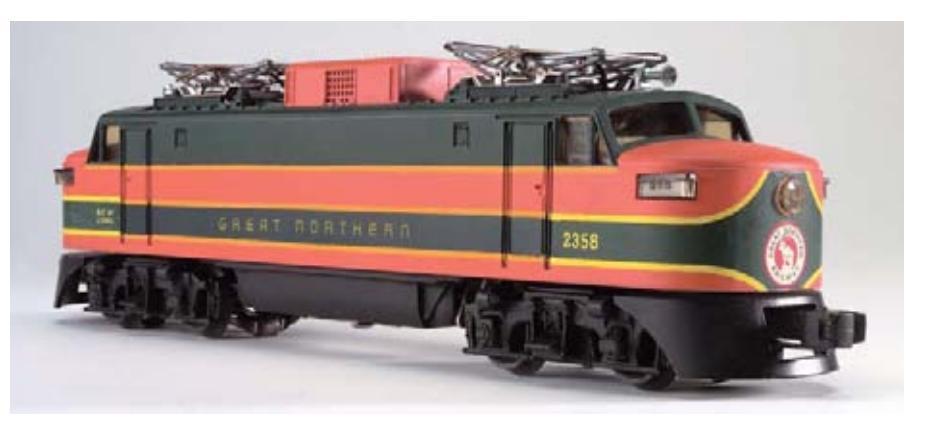
Like the 2350 New Haven, the 2358 used nose decals, which again have struggled with time. Decals often flake noticeably, particularly over the mounting rivet on the noses.

However, unlike the New Haven, the 2358 never got a painted-nose job before production ceased and the model was dropped from the catalog after 1960. It was the last of the postwar Lionel EP-5s.
